Water Resources Management Plan for the Water Sources and Mwange River Watershed in Gicumbi District

September 2018

Final Report

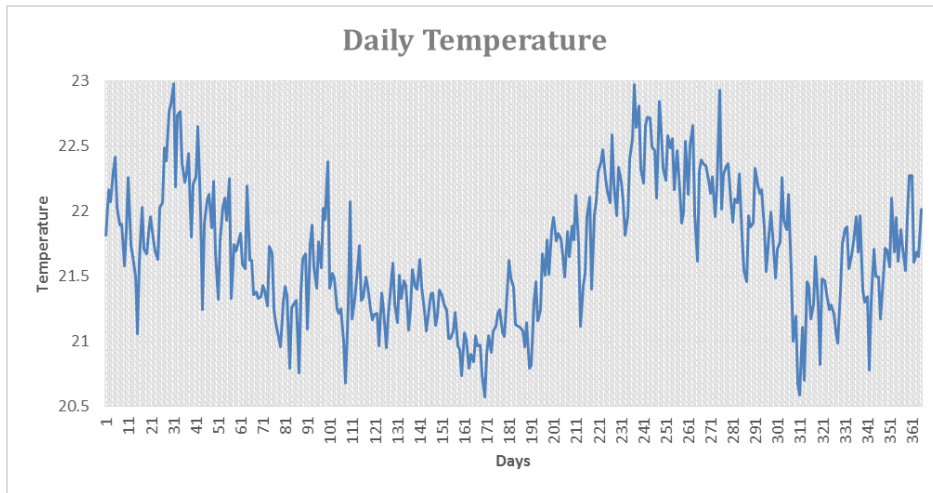
The temperature pattern varies between 20⁰ and 23⁰ Celsius as illustrated on figure 23. On average the catchment is observed to be a cool area. The pattern of temperature indicate normally that the sun energy supply, which consequently provides indication on how much water losses are to be expected through evapotranspiration in the area.

Figure 23: Daily temperature.

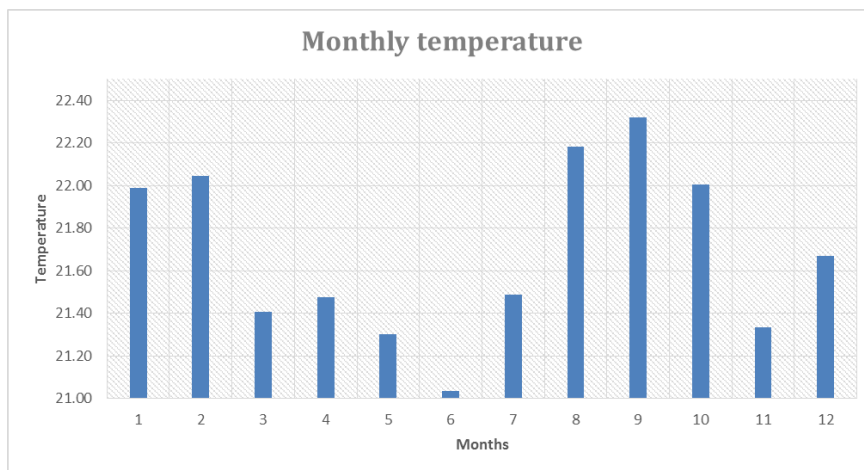
The pattern is clearly shown on the monthly figures illustrated in figure 24. Two patterns of high temperature are observed at the beginning of the year (January and February) and the middle end of the year (August, September and October).

Figure 24: Monthly Temperature.

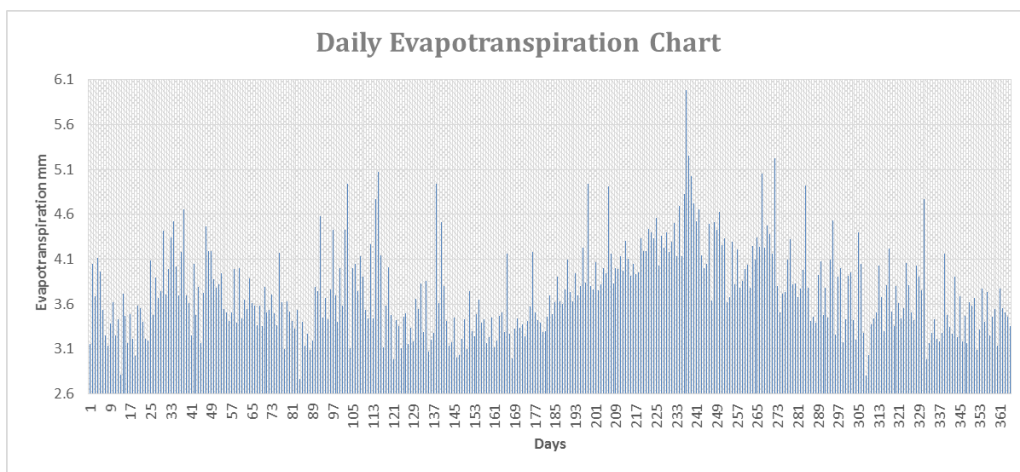
The evapotranspiration constitutes the biggest natural water loss of the Mwange River catchment. This process is a component of the water cycle, technically it is not a water loss however; for the purpose of water resources management it is considered as such because it cannot be harvested nor used. Its pattern differ from the rainfall. It can be observed from figure 25 that heavy daily evapotranspiration occurs in August. The reason of this trend can be explained by the fact that evapotranspiration occur when energy, water and plants are available. In August there is enough energy from the sun mixed with water in the natural system, additionally for the month of July an explanation of the high evapotranspiration will be related to the probable heavy transpiration from plants.

Figure 25: Daily evapotranspiration.

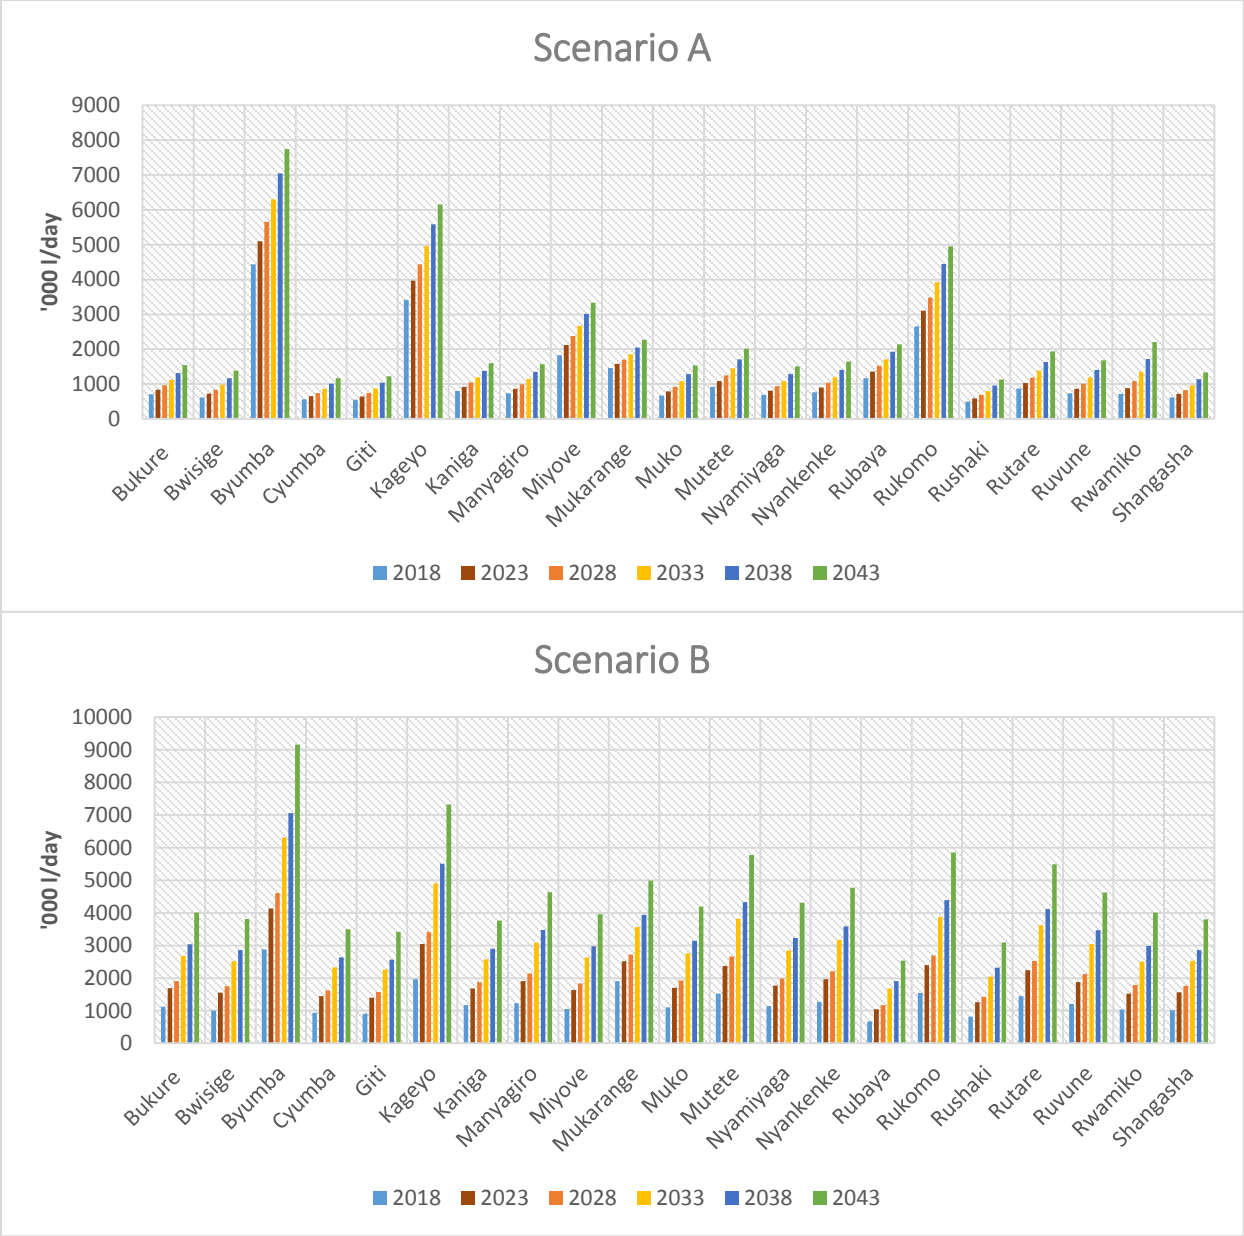
Figure 29: Water demand for Gicumbi District per sector estimation (A) conservation water consumption rate scenario; (B) scenario based on National Water Master Plan consumption rate

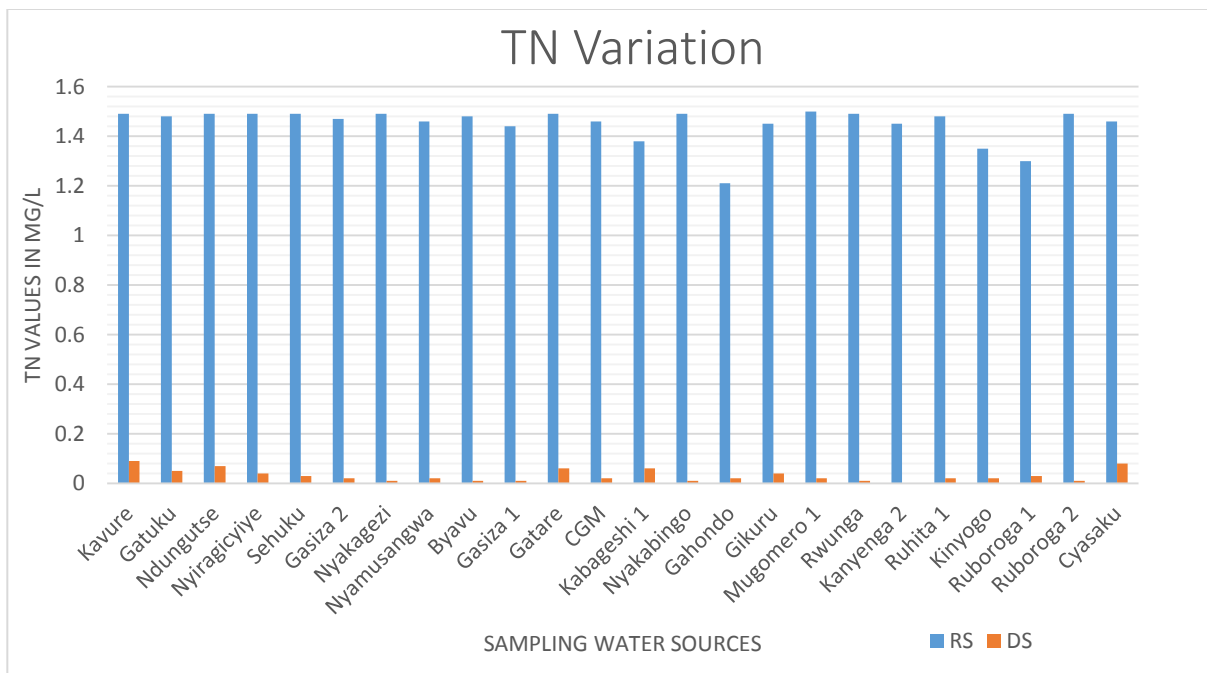
Figure 36: Variation in concentration of Total nitrogen in the first 24 water sources

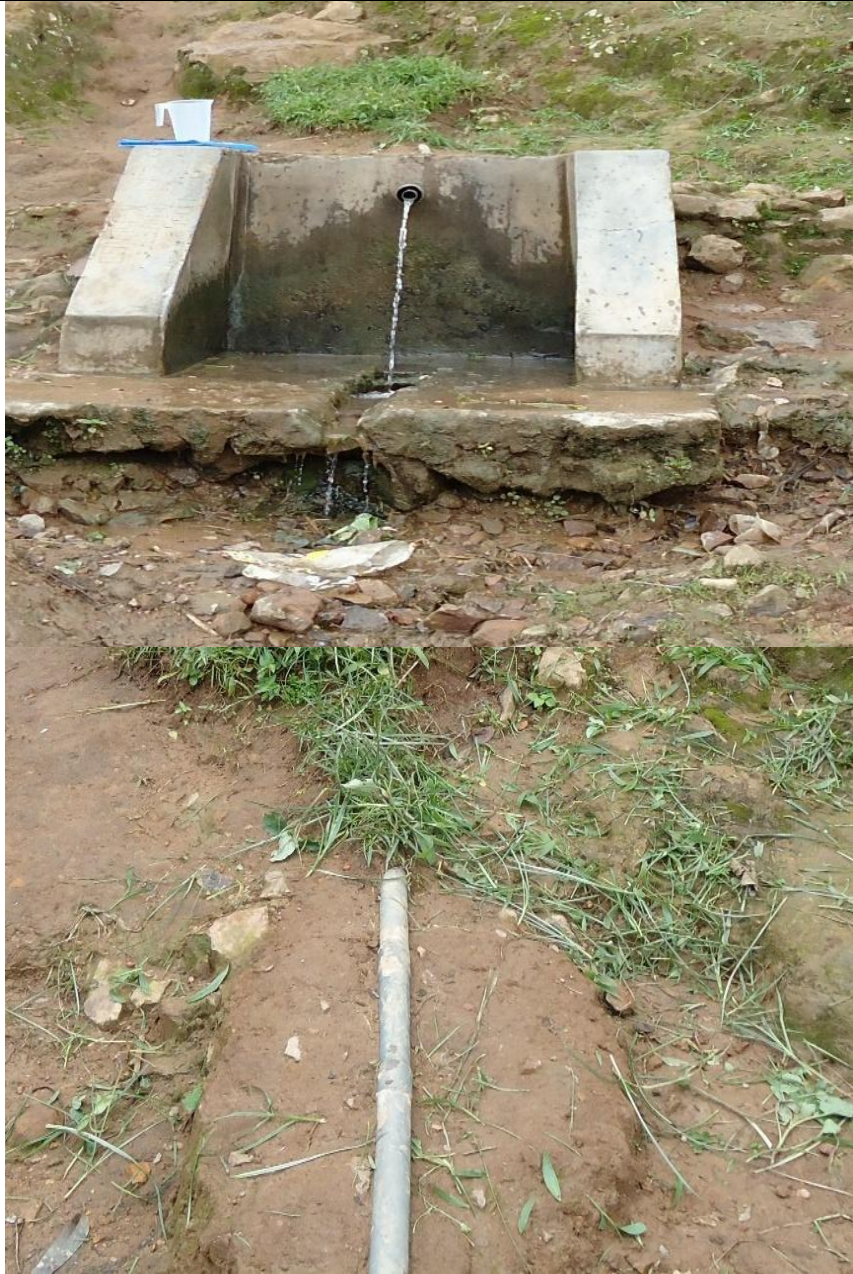
The water source catchment is not fenced and it is not protected. There is a path crossing the catchment area. In rainy season, source water gets dirty as the consequence of the mix of run off water with the source water.

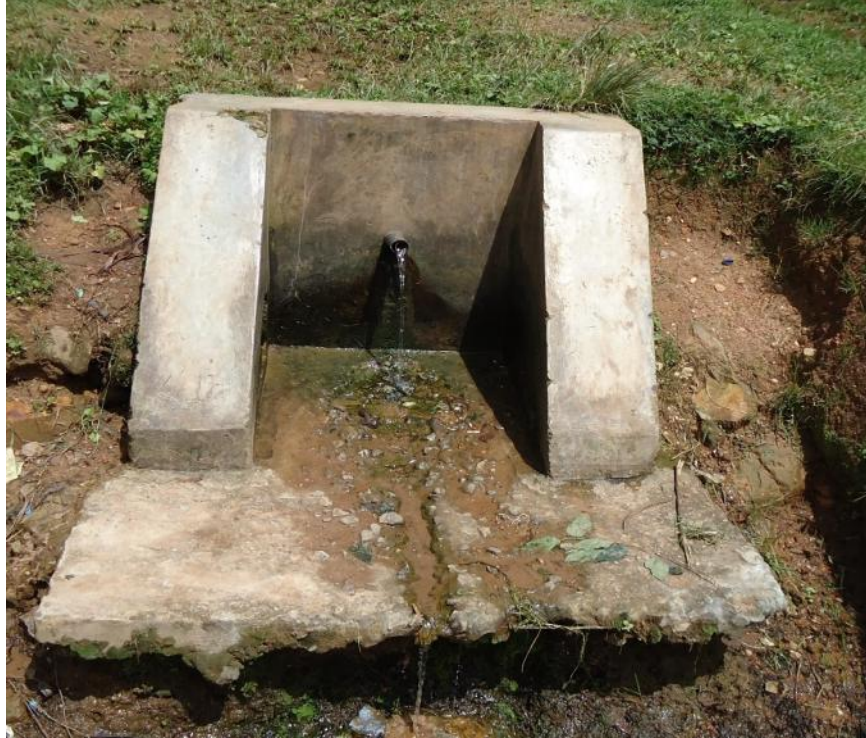
6.Sector :Byumba	Source name : GATUKU	Ref number : 020	Key notes

<p>The source catchment boundary is not clear because it is not fenced to depict it, the cathment area is not also protected properly. The source is not captured.</p> <p>Required management activities</p> <p>Capturing of the source spring water.</p> <p>Reestablishment of the spring catchment area.</p> <p>Establishment of water diversion ditch.</p>

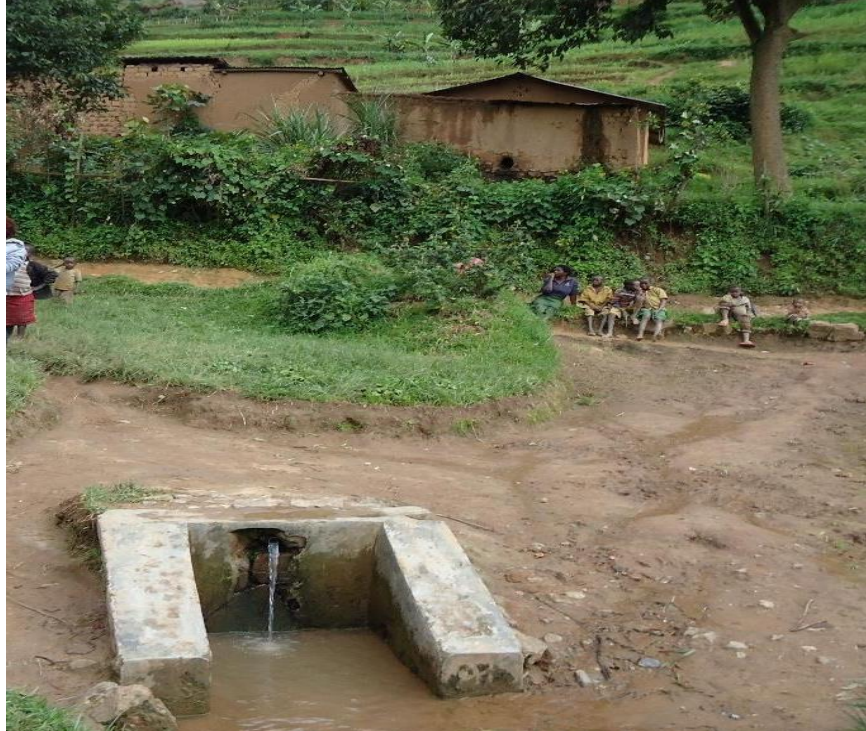
7.Sector:Byumba	Source name:NYAMUSANGWA	Ref number : 021	Key notes

<p>The Source water sometimes becomes dirty in rainy season.. The source catchment area is not protected and it is not fenced.</p> <p>The source catchment area is surrounded by households as it is shown on the picture.</p> <p>Required management activities</p> <p>Establishment of immediate spring catchment and fence it with imiyenzi.</p> <p>Establishment of a water diversion ditch.</p>

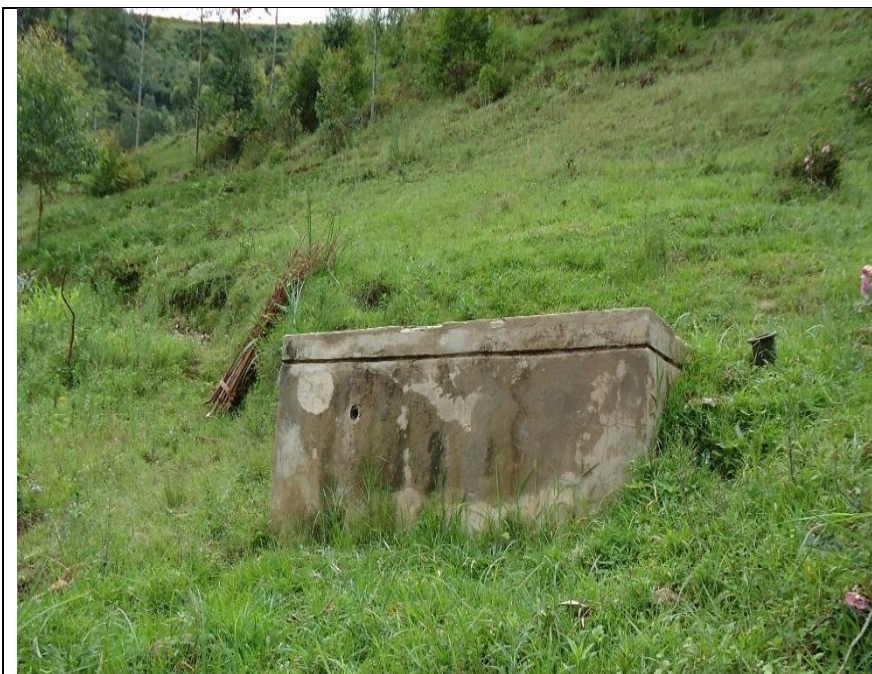
8. Sector:Byumba	Source name : MIRIKU	Ref number : 022	Key notes

The source is captured and its discharge is transported to NYAMABUYE water treatment plant.

The catchment area is protected but it is not fenced to show its boundaries and to protect life stock grazing.

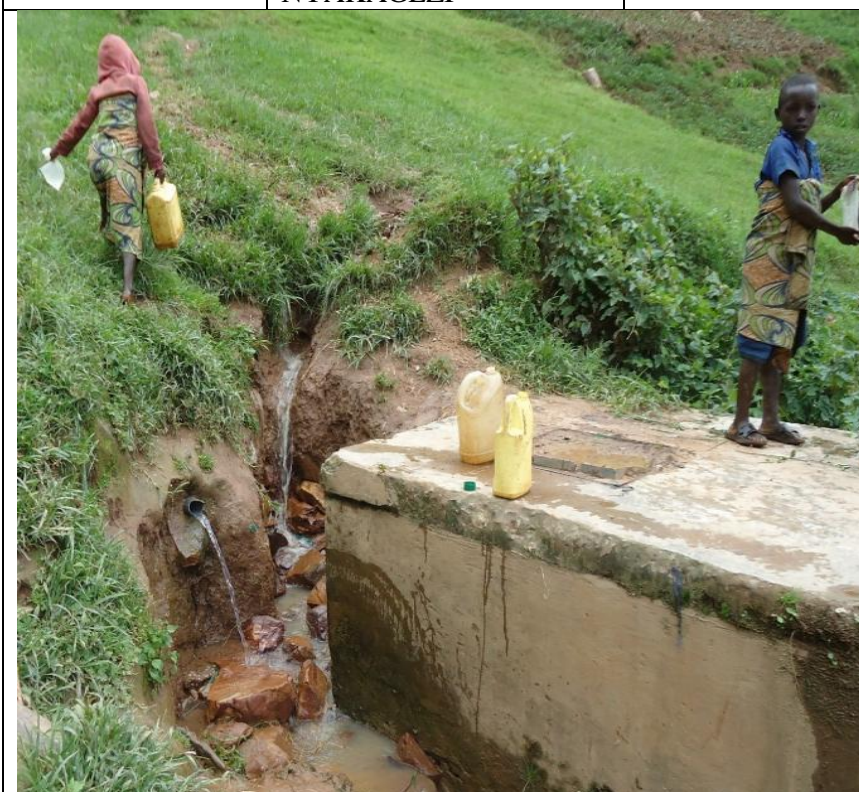
Ref number :023

The source is Captured but distribution pipes are damaged and the distribution line is no longer functioning.

There are no fences to protect the source point area, the water collection chamber is exposed to erosion and runoff water passes over the source catchment area.

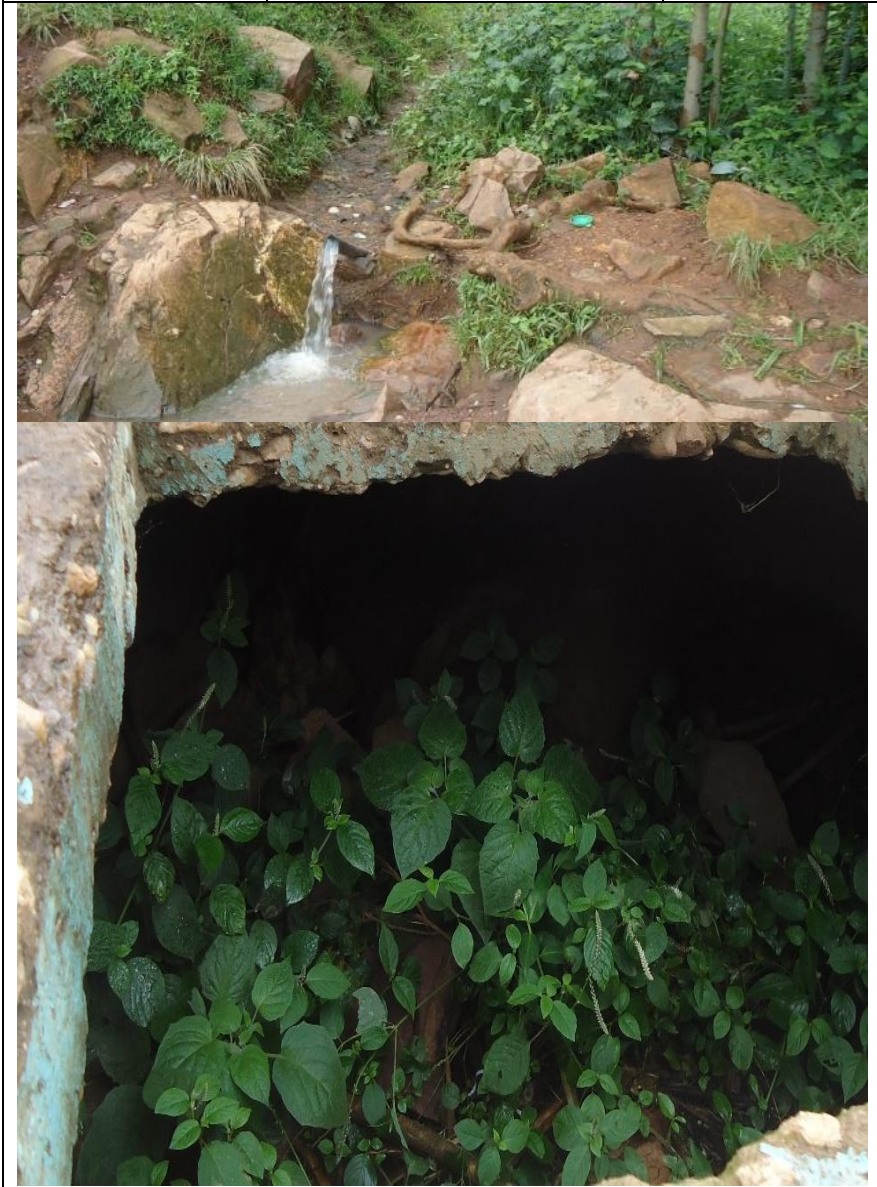
<p>KABAGESHI source is captured but it is damaged as it is shown on both pictures. The distribution system from this source is no longer operating and the water tank which collects water from the source is damaged at a higher extent as it is depicted on the picture.</p> <p>The catchment area is not fenced and it is not protected at all.</p> <p>Water from the source sometimes becomes dirty due to runoff water which easily penetrates in the source point.</p> <p>Required management activities</p> <p>Immediate rehabilitation of the entire source and the distribution system as well.</p> <p>Establishment of fences around the catchment area.</p> <p>Establishment of source water diversion ditch around the spring immediate.</p>

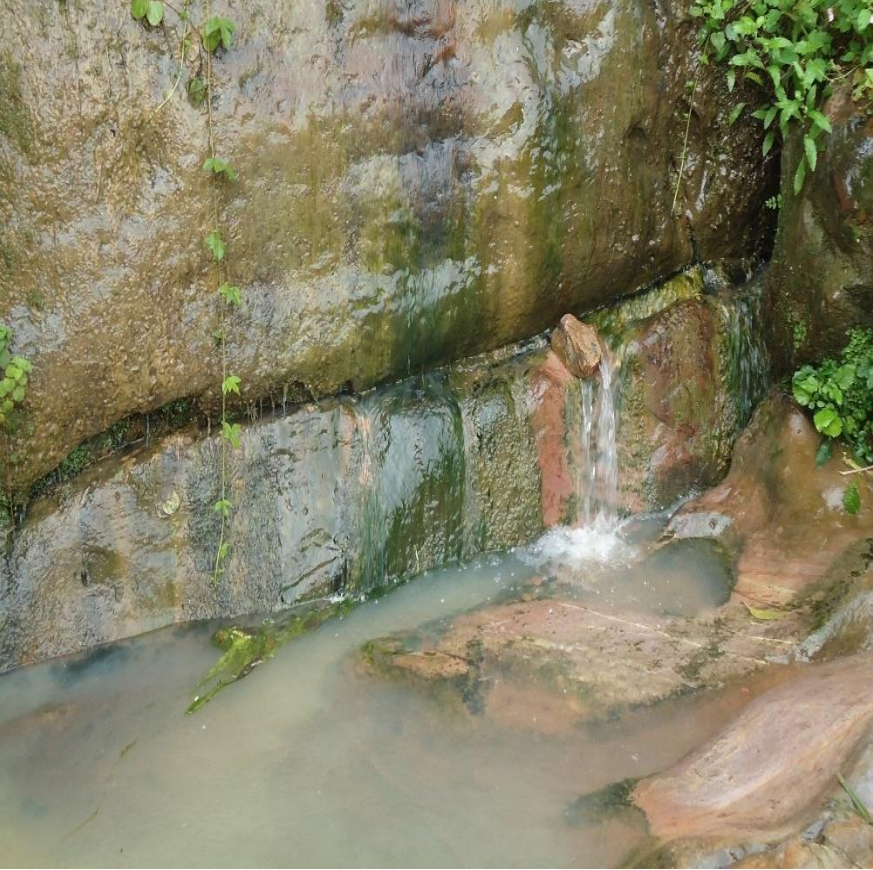
31 .Sector:Kageyo	Source name: MUGOMERO 1	Ref number : 50	Key notes

<p>The water source needs to be captured. The catchment area is not protected and doesn't have fences. The source discharges water through the rock and during rainy season, water usually becomes dirty.</p> <p>Guide: GASAGURE Ildephonse Tel : 0722827283</p> <p>Required management activities</p> <p>Capturing of the source water is required. Establishment of a water diversion way, fence and protect the catchment area.</p> <p>Construction of the standard spring's fetching area is required.</p>

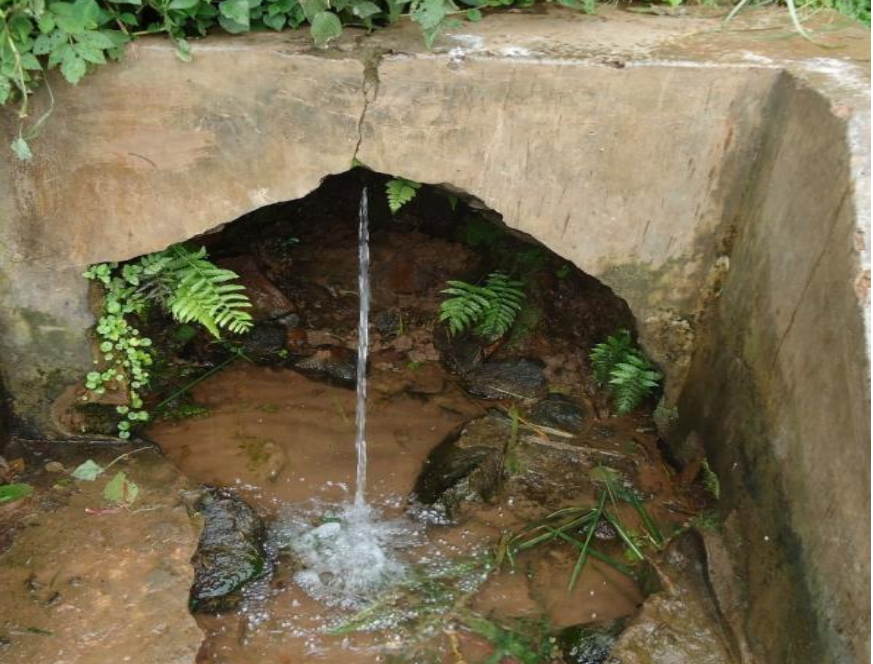
32. Sector:Kageyo	Source name: MUGOMERO 2	Ref number : 49	Key notes

<p>Needs to be rehabilitated Water is always clear and clean. The source is not captured and its catchment area is not protected. The source discharge area is damaged and needs to be rehabilitated and maintained.</p> <p>Required management activities</p> <p>Capturing of the source water and immediate rehabilitation is needed .</p> <p>Maintenance and fencing of the spring catchment is necessary.</p>

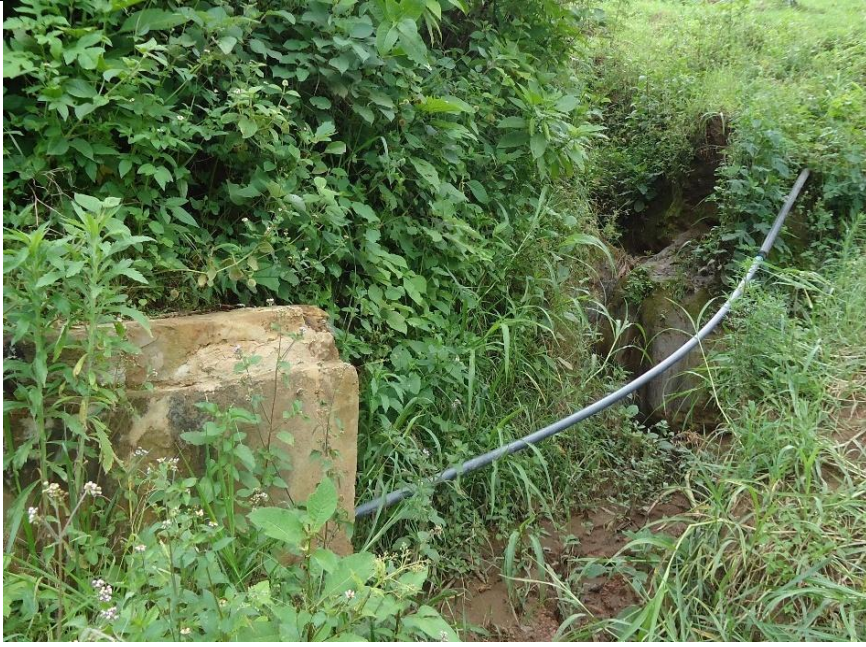
37.Sector: Kaniga	Source name : NYAKEGA	Ref number : 059	Key notes

<p>The source is captured but not properly and needs total rehabilitation. The source catchment area doesn't have fences and it is not protected.</p> <p>Required management activities Re-capture the source to make all water of spring useful.</p> <p>Establishment of fences around immediate source catchment is required to protect both water quality and quantity of the source.</p>
38.Sector:Kaniga	Source name: RUHITA 2	Ref number : 061	Key notes

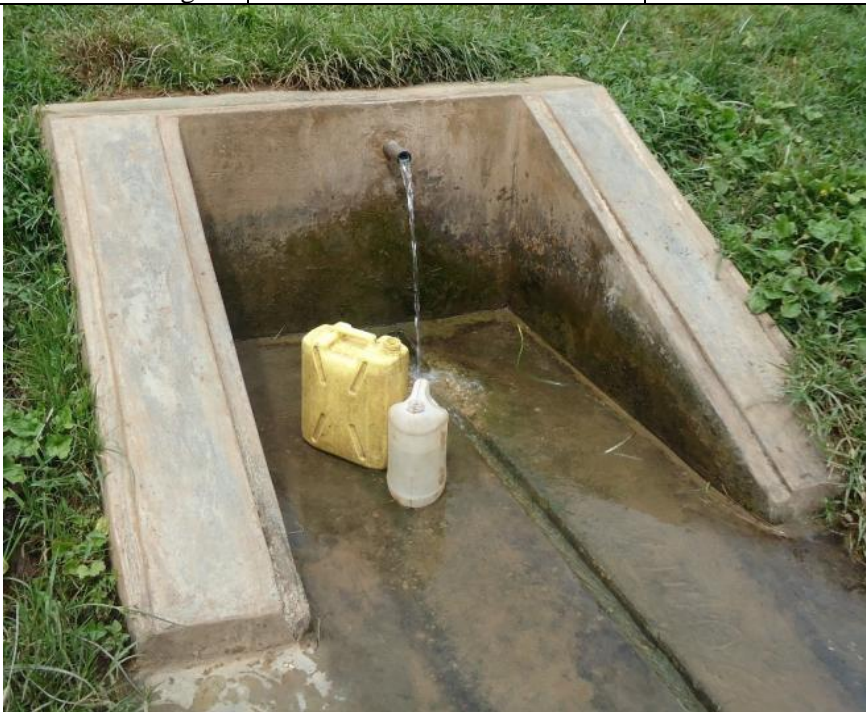
<p>The source is not captured and its catchment area is not protected and doesn't have fences. Water is always clear and clean.</p> <p>Required management activities Capturing of the source is required.</p> <p>Establishment of fences around source catchment is required.</p>

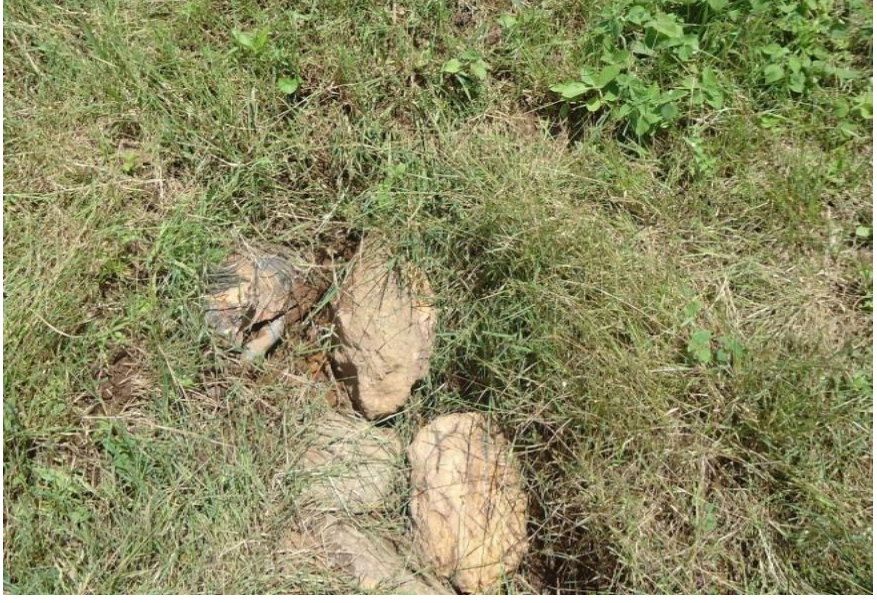
44.Sector: Rushaki	Source name : NYAGAHANGA	Ref number:072	Key notes

<p>The source is captured but not properly. The catchment doesn't have fences and hence not protected properly.</p> <p>Required management activities</p> <p>Re-capture the source to make all water of the source useful. Establishment of fences around immediate spring catchment and protect the source for both water quality and quantity of the source.</p>

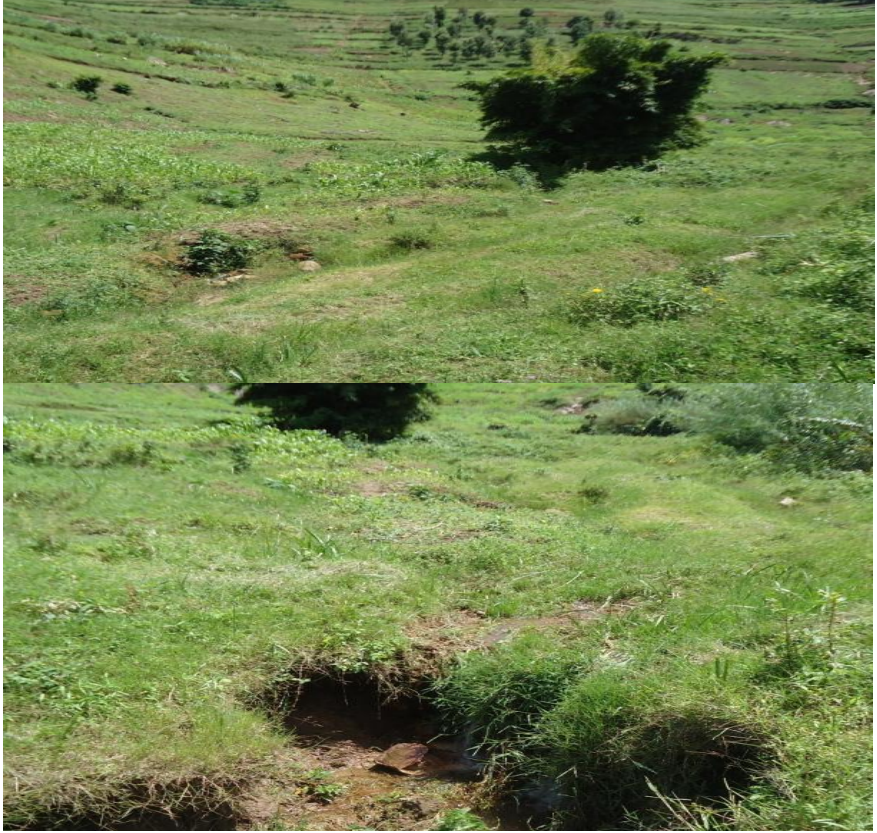
45. Sector: Kaniga	Source name : RWABONA	Ref number: 070	Key notes

<p>The sources from Rwabona are neither captured nor in use. As it is illustrated, they have higher discharges. The catchment area is protected but without fences.</p> <p>Required management activities</p> <p>Capturing sources of Rwabona for future use. Surround the catchment area with fences. Pave water diversion paths in order to eliminate the interaction between spring water and the runoff.</p>

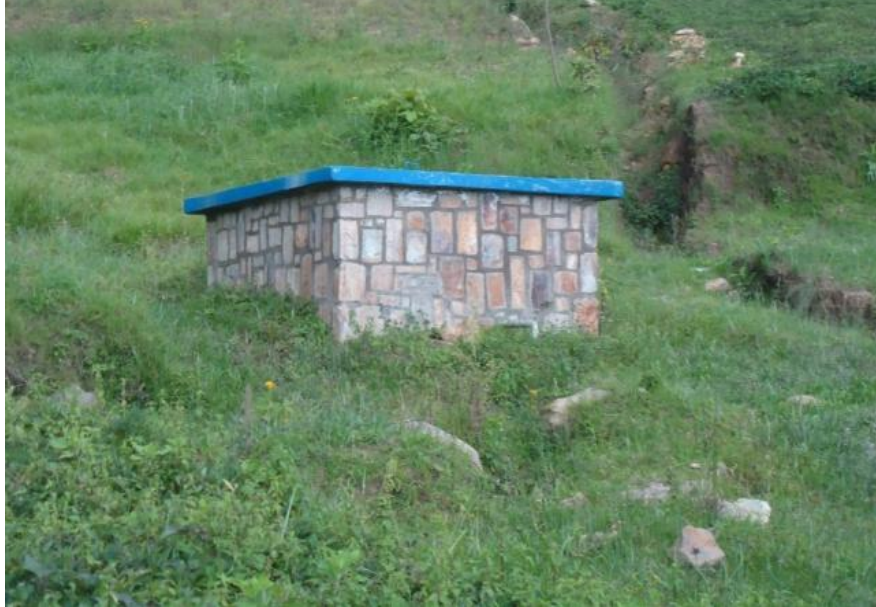
55. Sector: Manyagi	Source name:Rwungo 3	Ref number :87	Key notes

<p>The source is captured and is well maintained and the catchment area is protected but without fences.</p> <p>Required management activities Introduce fences around the catchment area and maintain the existing trenches.</p>
56. Sector : Manyagi	Source name :Rwungo 4	Ref number:88	Key notes

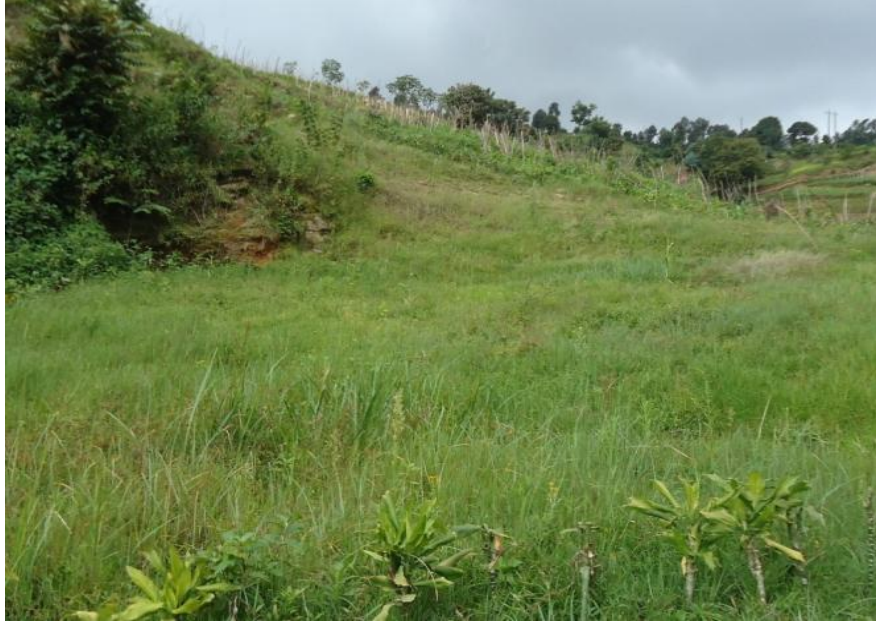
<p>The source is captured and is well maintained and the catchment area is protected but without fences.</p> <p>Required management activities Introduce fences around the catchment area and clear the zone.</p>

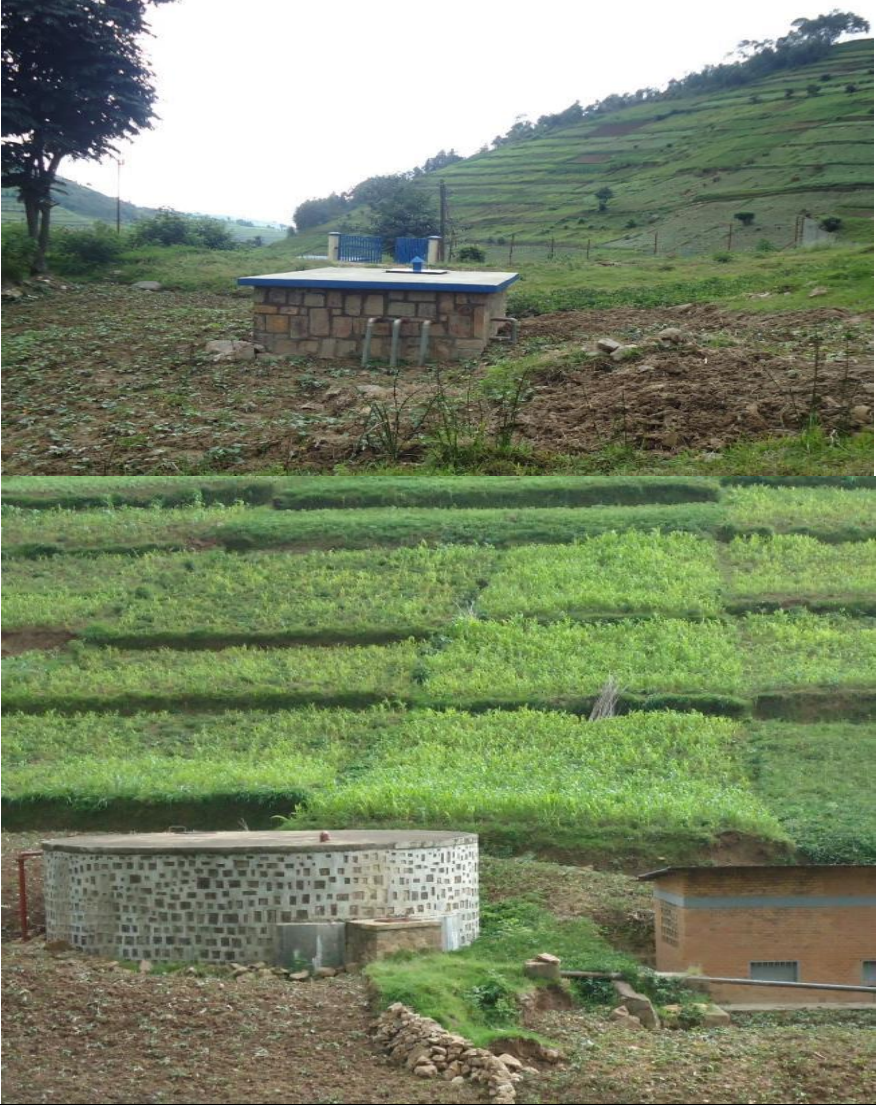
57.Sector: Manyagiro	Source name : Rwungo 5	Ref number:89	Key notes

<p>The source is captured and is well maintained and the catchment area is protected but without fences.</p> <p>Required management activities Introduce fences around the catchment area.</p>
58. Sector :Manyagiro	Source name :Murehe 1	Ref number :091	Key notes

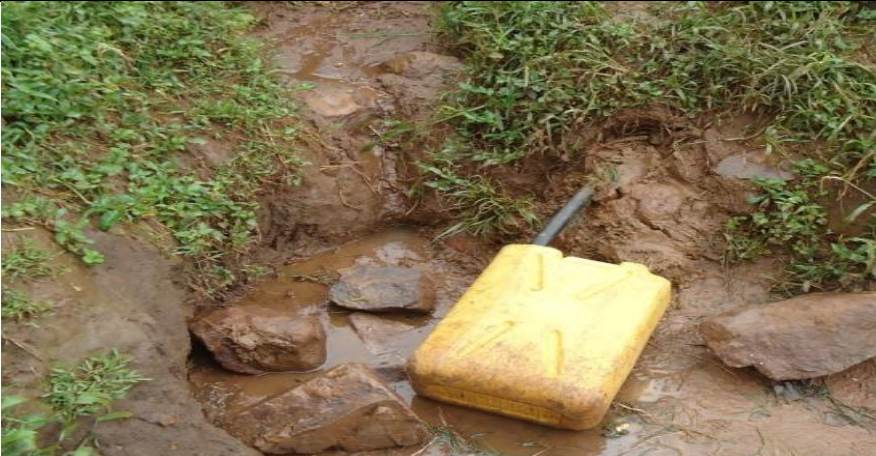
<p>The catchment area is neither fenced nor protected. The source is not captured and is exposed to erosion.</p> <p>Required management activities Introduce fences and protect the catchment area. Capturing of the source is required and introduces terraces upstream to prevent its exposure to erosion.</p>

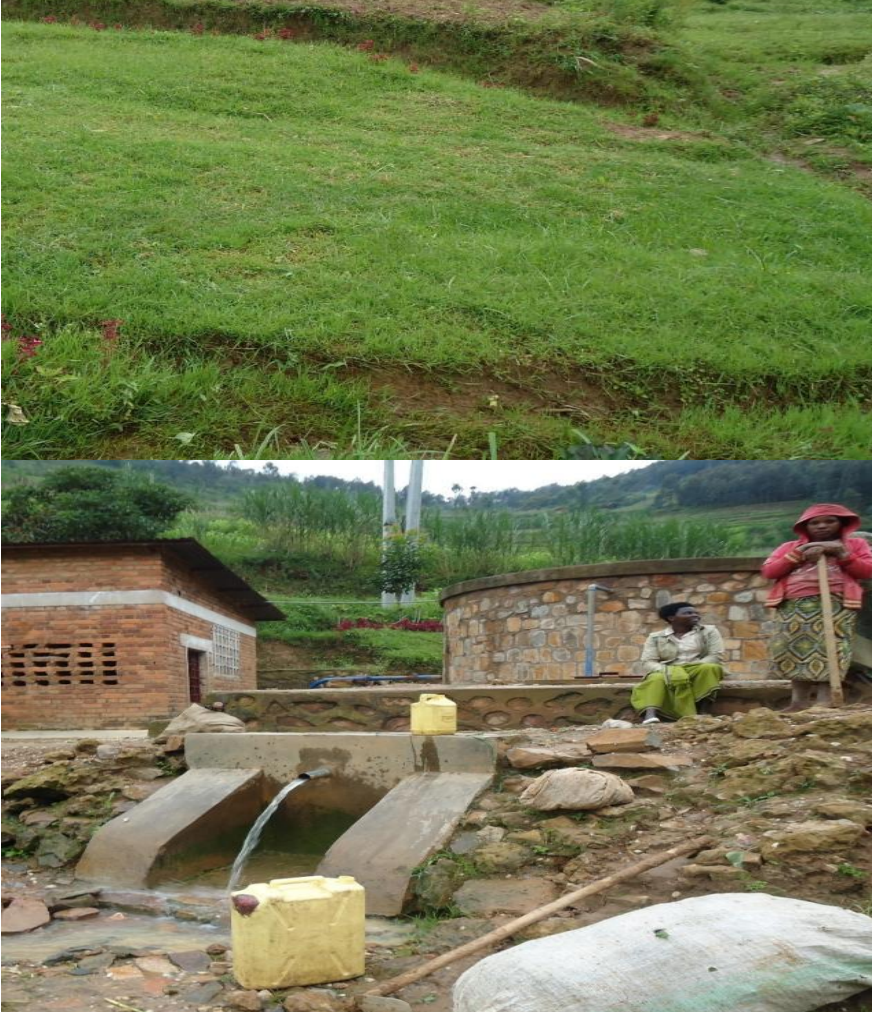
<p>The source is captured and there is a reserved area for the catchment but it doesn't have fences. Water becomes dirty in rainy season. Some of the pipes of the distribution line are exposed to erosion.</p> <p>Required management activities Establishment of the spring catchment area with fences and protect it. Introduce terraces upstream.</p>

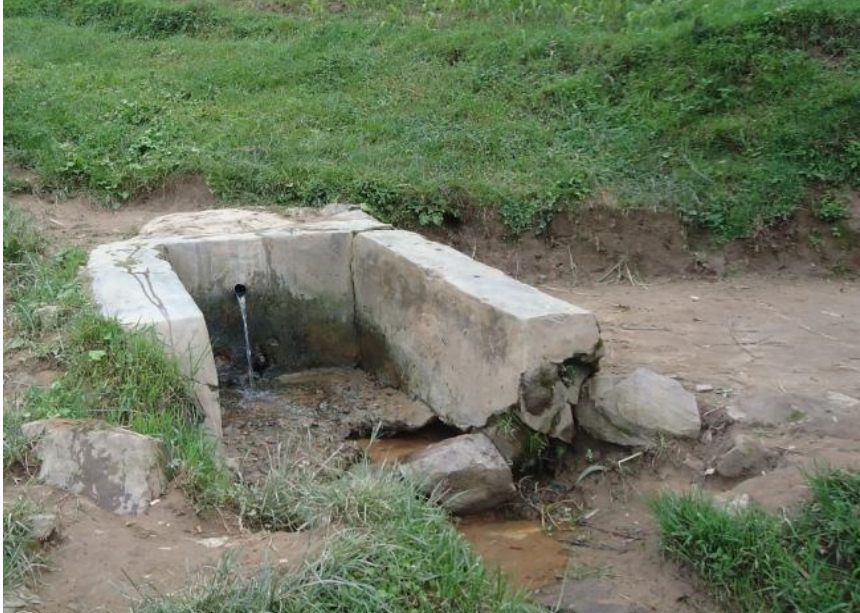
69. Sector:Byumba	Source name:NYARUBANDE	Ref number :105	Key notes

<p>The source is captured and its catchment area is not protected and doesn't have fences.</p> <p>Guide : SINAYIRAZWE Mathias Tel : 0785080064</p> <p>Required management activities Introduce fences and protect the catchment area. Rehabilitation of the spring is also needed.</p>
70. Sector :Ruvuna	Source name:KABINGO	Ref number:106	Key notes

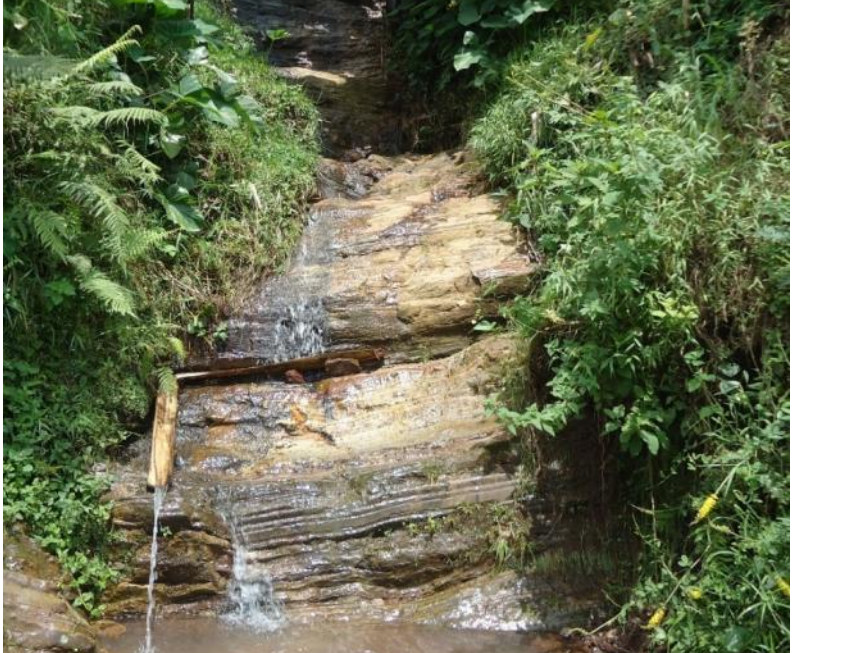
<p>The source is not captured and doesn't have a water tap. The catchment area is not protected and it is surrounded by a lot of bushes.</p> <p>Required management activities Capture the source, and introduce a standard water tap to the source. Introduce fences, clear the surrounding, and protect the catchment area.</p>

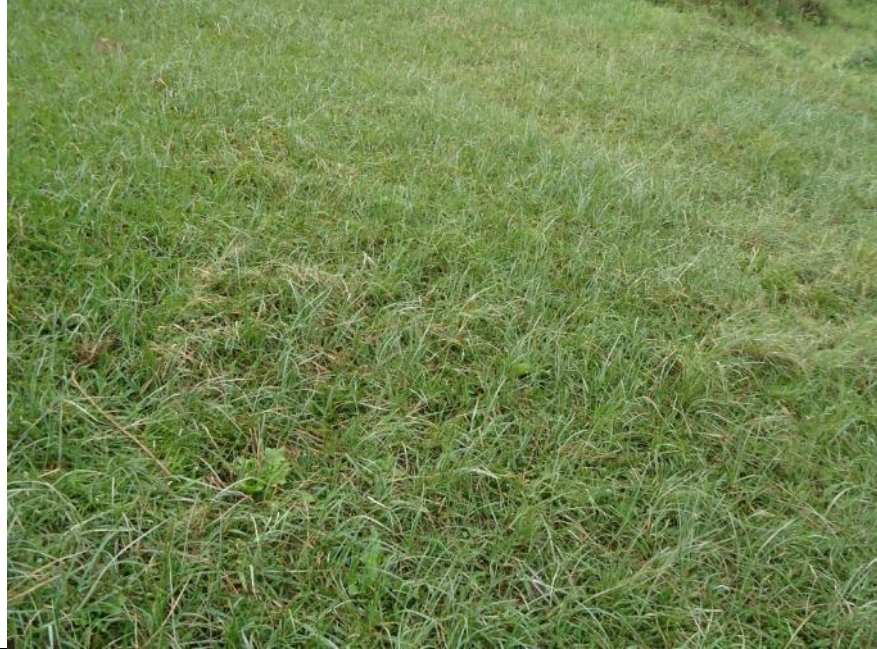
77. Sector :Rukomo	Source name :KARIBA 1	Ref number :117	Key notes

<p>The source is captured but it does have a collection chamber, its catchment is protected and covered by the natural vegetation but it is not fenced.</p> <p>Required management activities. Install a collection chamber, and it should be secured and locked. Introduce fences around the catchment area.</p>
78. Sector:Rukomo	Source name:KARIBA 2	Ref number :118	Key notes

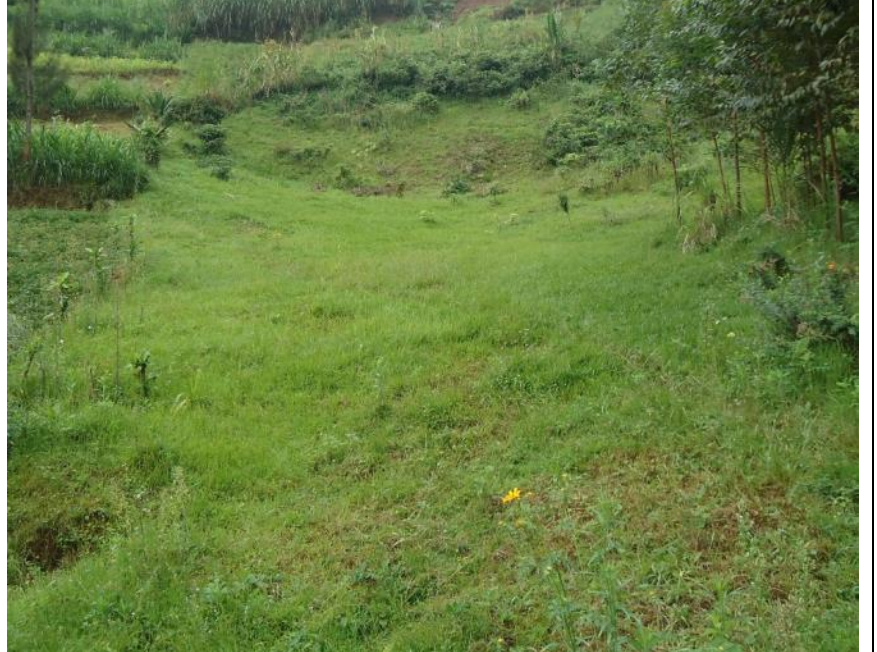
<p>The source is Captured but it doesn't have a collection chamber, its catchment area is protected but not fenced. The surrounding area is covered by the bushes and shrubs.</p> <p>Required management activities Install a collection chamber, secure it, and lock it. Introduces fences on the catchment area and clear it.</p>

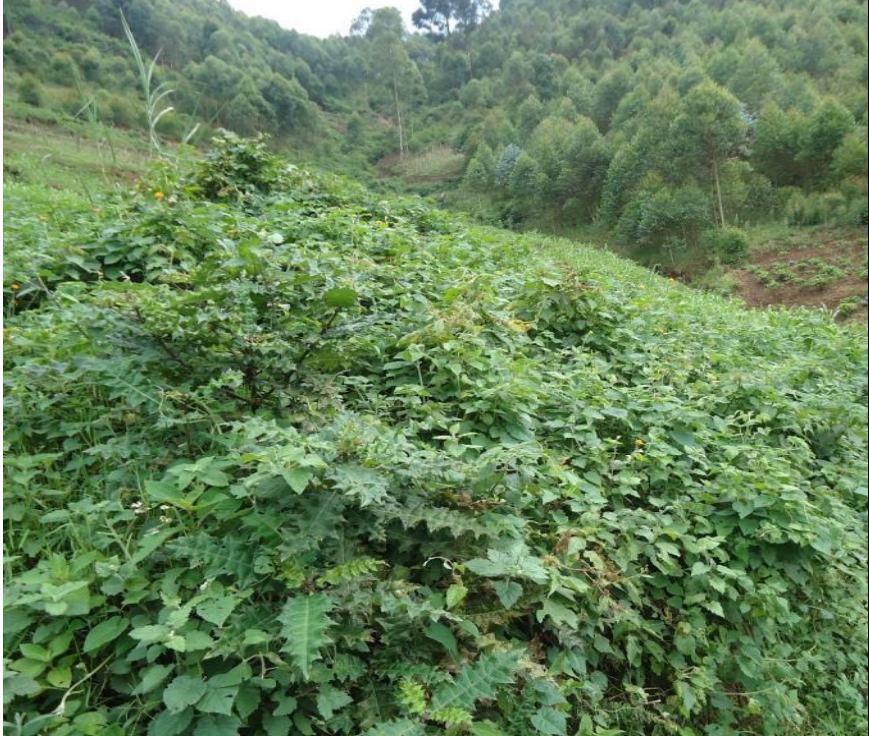
82. Sector :Shangasha	Source name : NYAKABINGO 4	Ref number :122	Key notes

<p>The source catchment area is not protected and most of the catchment area is covered by bushes as illustrated on the picture.</p> <p>The source of water is captured but without a collection chamber, water is conveyed directly to the tank. The upstream area of the source is covered by forest plantation of eucalyptus.</p> <p>Required management activities Introduces fences, clear and protect the catchment area. Install a collection, secure it, and lock it. Clearance of eucalyptus on the vicinity of the source.</p>

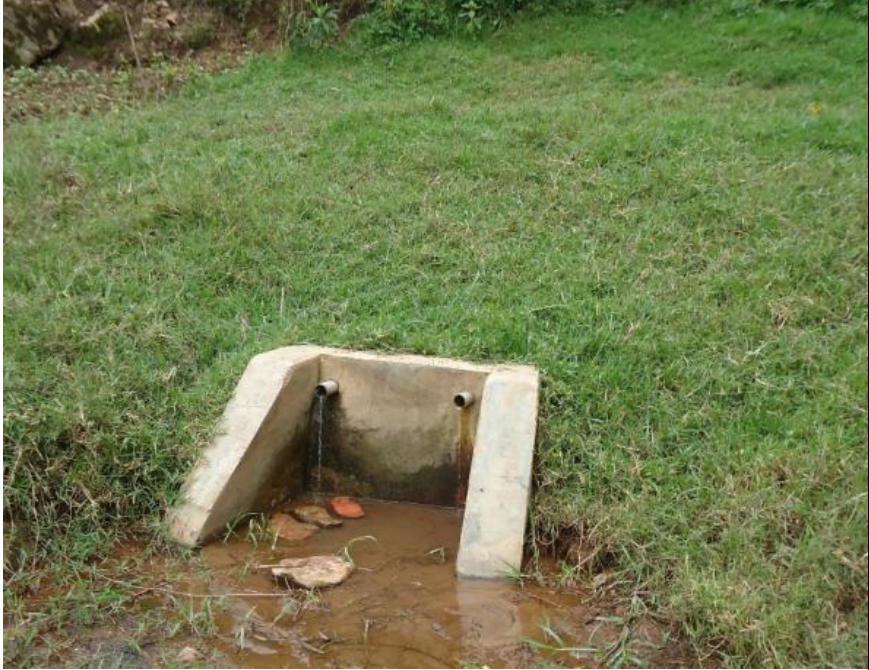
83. Sector:Shangasha	Source name: KABAYI	Ref number :123	Key notes

<p>The catchment area of the source is not fenced and it is not also well protected.</p> <p>In addition to that, most of the source water is diverted. As a result, only water with 0.02 l/s flow rate is discharged and it is still talking the normal flow rate. The spring discharges water through two main pipes and some of the spring water leaks.</p> <p>Required management activities Introduces fences and well protect the catchment area. Establish a diversion ditch downstream.</p>

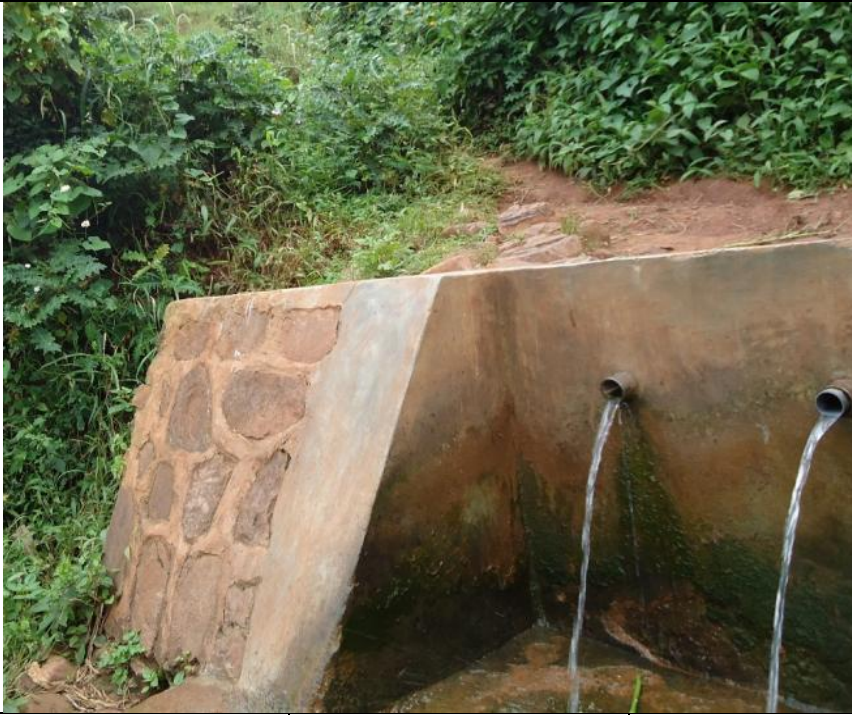
93. Sector :Rutare	Source name: GATARE	Ref number :135	Key notes

<p>The source is captured and its catchment area is not protected and it is not fenced as well. Water becomes dirty in rainy season. The catchment area is surrounded by the shrubs and bushes which imply that the source needs a proper maintenance and clearance. The spring discharges water through two main pipes as it is illustrated on the picture.</p> <p>Required management activities. Introduce fences and protect the catchment area. Establish diversion pathways upstream.</p>
