Water Resources Management Plan for the Water Sources and Mwange River Watershed in Gicumbi District

September 2018

Final Report

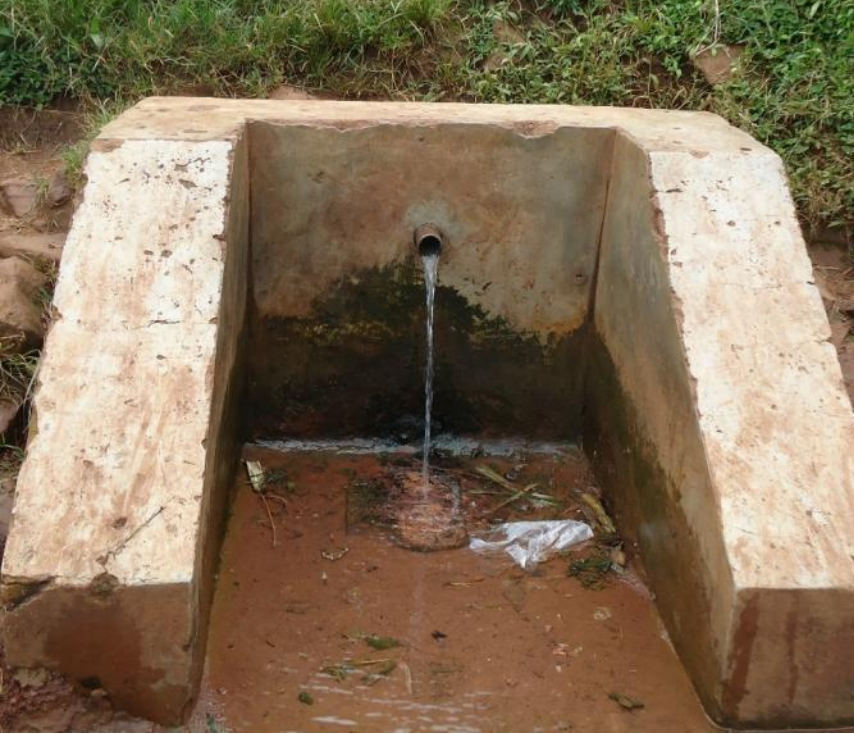
97. Sector:Giti	Source name:KANYAMA	Ref number:139	Key notes

<p>The source is not captured and its catchment area is not protected and it is not fenced.</p> <p>Water from Kanyama source sometimes becomes dirty in rainy season. .</p> <p>The source point is covered with lots of bushes.</p> <p>Required management activities</p> <p>Capture the source, introduces fences, and protect the catchment area.</p> <p>Clear the source, and introduces diversion pathways and terraces upstream.</p>

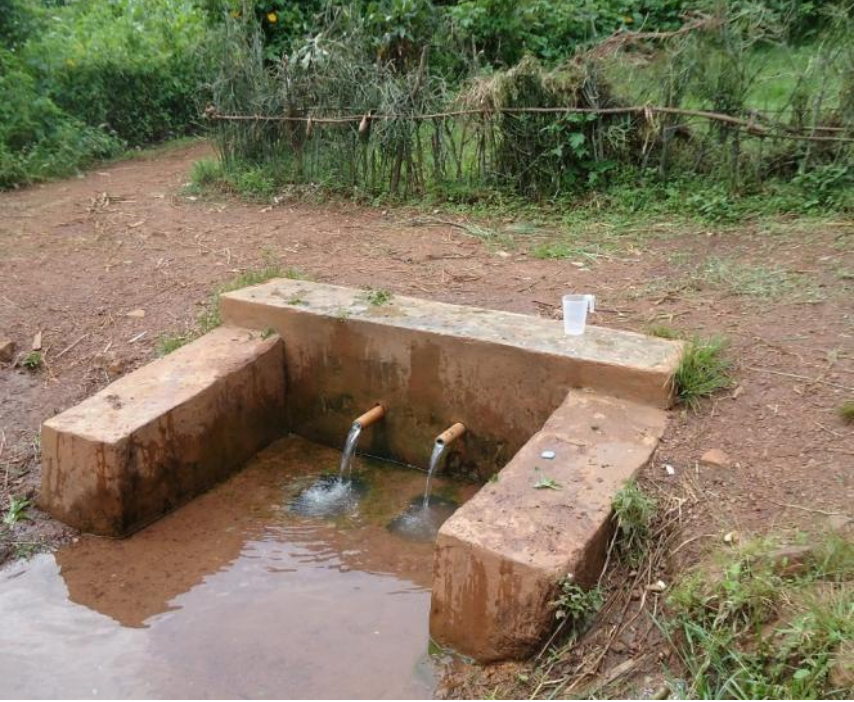
98. Sector:Giti	Source name:RUHONDO	Ref number :140	Key notes

<p>The source is newly rehabilitated but it is exposed to erosion.</p> <p>The source is not captured and has a protected catchment with fences.</p> <p>The spring discharges water through two main pipes and some of the spring water leaks.</p> <p>Required management activities</p> <p>Introduces terraces upstream to prohibit erosion exposure.</p> <p>Reinforce the existing fences and establish a water diversion ditch downstream.</p>

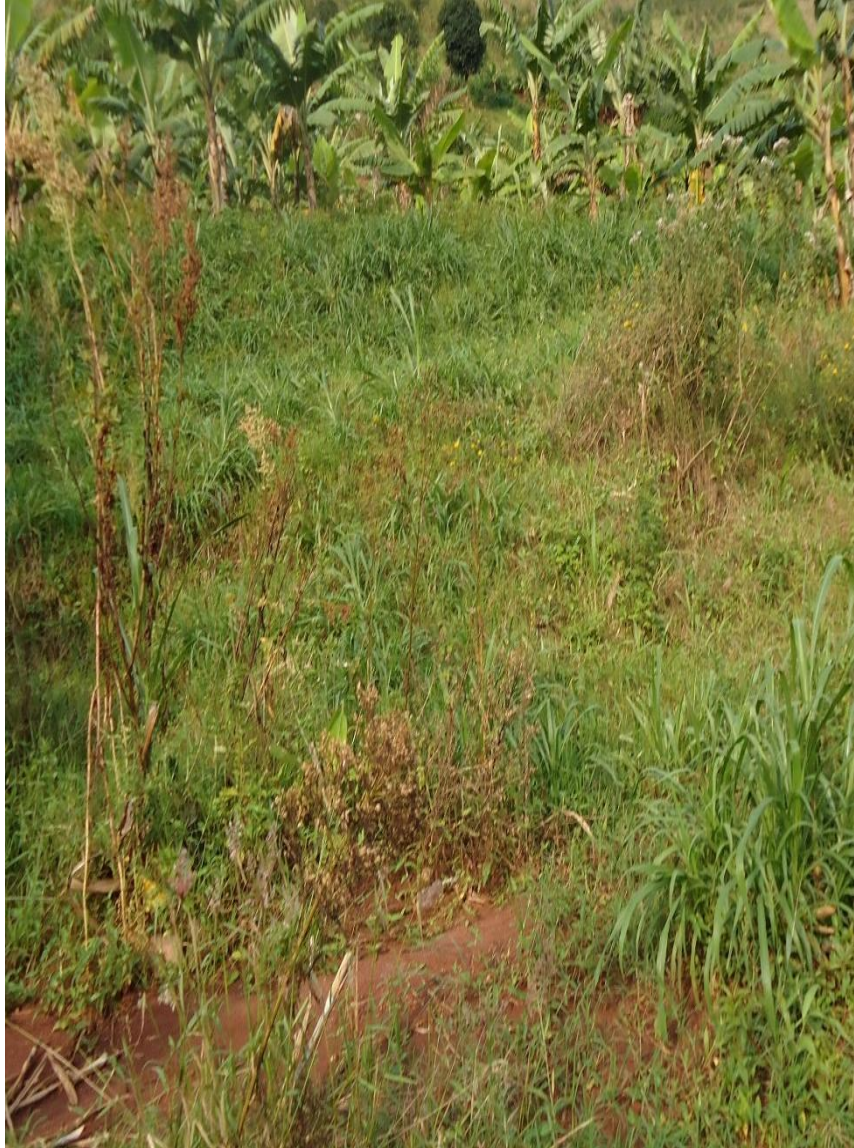
<p>The source is captured and its catchment is not protected and it is not fenced.</p> <p>The source point was hit by severe erosion and the collection chamber is now covered by soils and can't be easily accessed.</p> <p>The catchment area is surrounded by banana plantation and bushes as it is illustrated on the picture.</p> <p>Required management activities</p> <p>Introduce fences around the catchment area and protect it.</p> <p>Introduce terraces and trenches upstream to prohibit the exposure of the source to erosion again.</p> <p>Immediate rehabilitation of the collection chamber and removal of banana trees to the vicinity of the source.</p>

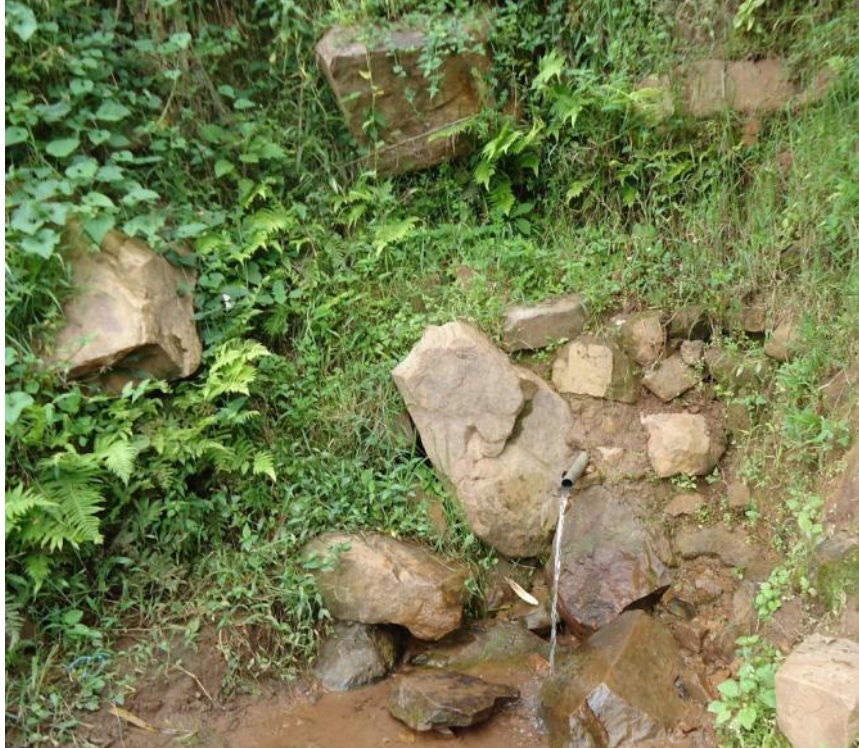
111. Sector:Mutete	Source name: MARUMBA	Ref number:154	Key notes

<p>The source is not captured and its catchment is not fenced and it is not protected. The catchment area is covered by rocks and natural vegetation.</p> <p>Required management activities. Capture the source, introduce fences, and protect it. Rehabilitate the source and establish a standardized spring feature.</p>
112. Sector :Mutete	Source name: MAGANGA	Ref number :154	Key notes

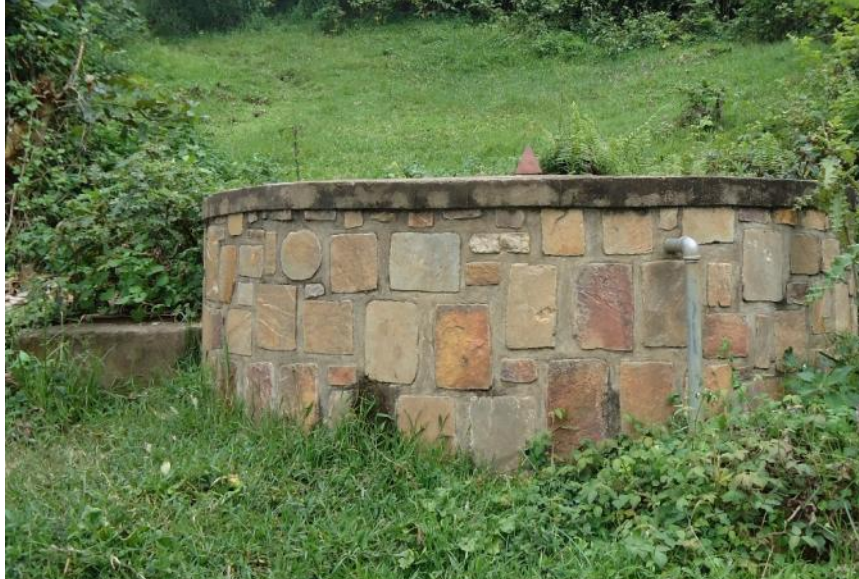
<p>The source is captured and its catchment area is not fenced but it is protected. The distribution system needs to be rehabilitated and it is covered by the bushes.</p> <p>Required management activities Introduce fences around the catchment area. Rehabilitate the distribution system and clear the surrounding.</p>

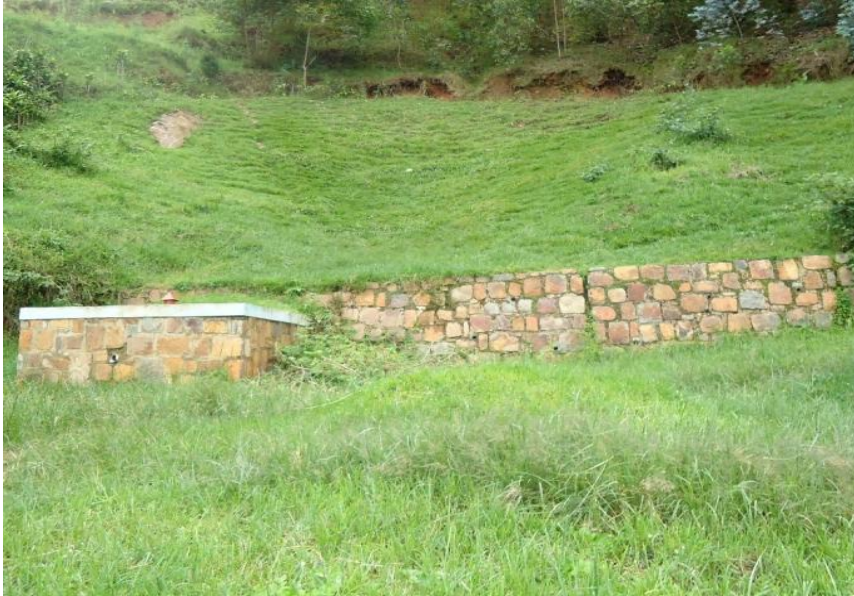
115. Sector:Nyankenke	Source name: KABAHURA	Ref number :156	Key notes

<p>The source is captured and its catchment area is not protected and does it is not fenced as well. Water becomes dirty in rainy season. The distribution station area is covered by natural vegetation.</p> <p>Required management activities Introduce fences and protect the catchment area. Establish water diversion pathways.</p>
116. Sector:Byumba	Source name: RYARUGANZU	Ref number:157	Key notes

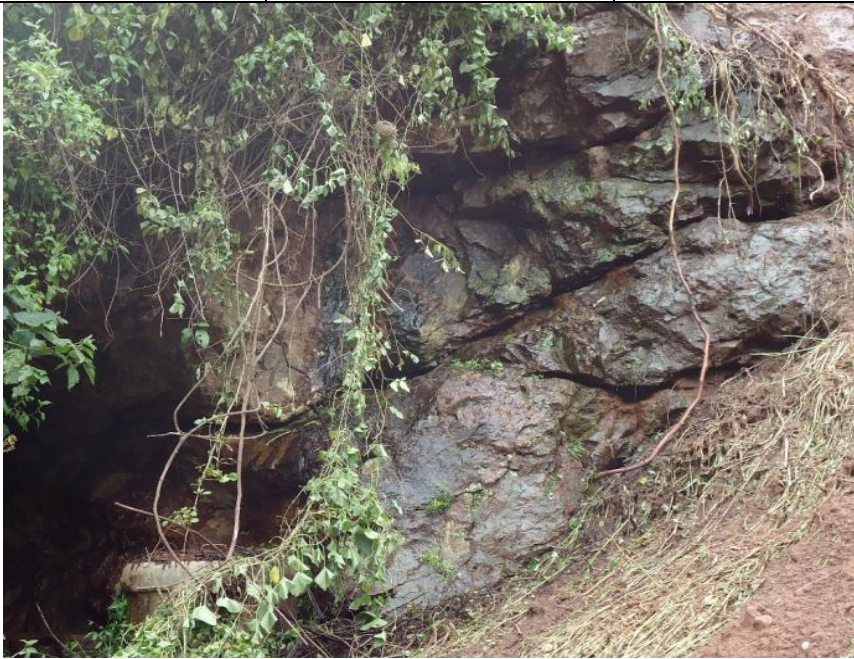
<p>The source is captured and the catchment area is not protected and it is not fenced at all. The immediate rehabilitation is needed. The source point is within and covered by rocks as it is illustrated on the picture.</p> <p>Required management activities Introduce fences and protect the catchment area. The immediate rehabilitation of the source is required.</p>

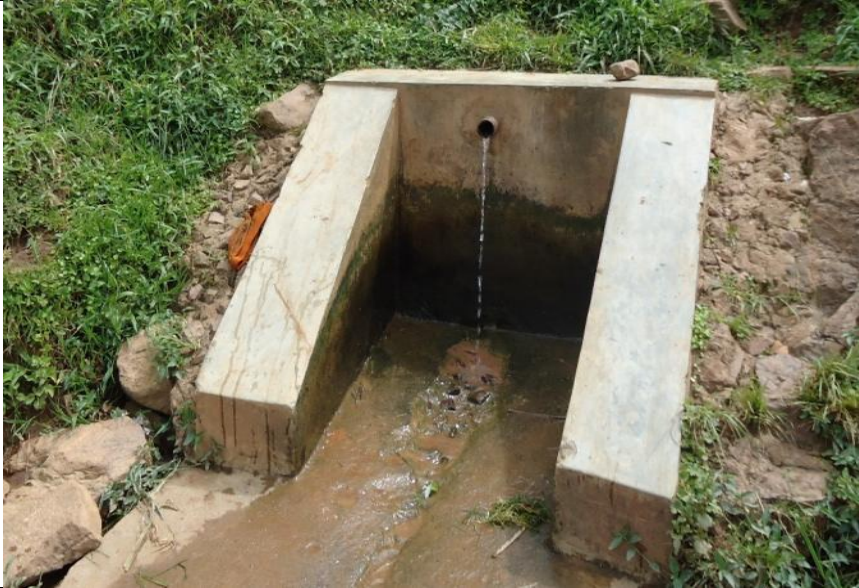
117. Sector:Rukomo	Source name: Mugomero	Ref number :158	Key notes

<p>The source is not captured and the catchment area is not protected and it is not fenced.</p> <p>At some part of the source water is diverted.</p> <p>Required management activities Capture the source, introduce fences, and protect the catchment area. Establish a diversion ditch downstream.</p>
118. Sector:Rukomo	Source name: NYAMABUYE 1	Ref number :159	Key notes
 			<p>The source is captured and the catchment is not protected and it is not fenced at all.</p> <p>The distribution system area is covered by the bushes and it is surrounded by unprogressive terraces.</p> <p>Required management activities Introduce fences and protect the catchment area. Reinforcement of the existing terraces.</p>
